**AERONAUTICAL ACCIDENT INVESTIGATION
AND PREVENTION CENTER**

**FINAL REPORT
A-00X/CENIPA/2008**

OCCURRENCE: AERONAUTICAL ACCIDENT

ACFT REGISTRATION: PR-GTD and N600XL

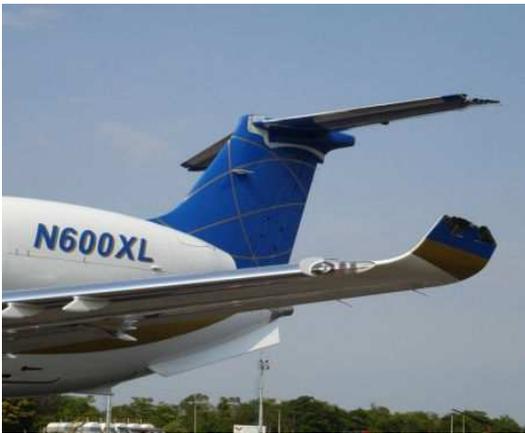
Figure 1

On the occasion, an external inspection was made so as to observe the structural damage sustained by the N600XL airplane. In summary, the following damages were seen: break of the left wing winglet (Figure 1), varied deformations on the left wing and a cut on the fairing of the left tip of the horizontal stabilizer, both on the left side (Figure 2).

Damaged tail and winglet, N600XL

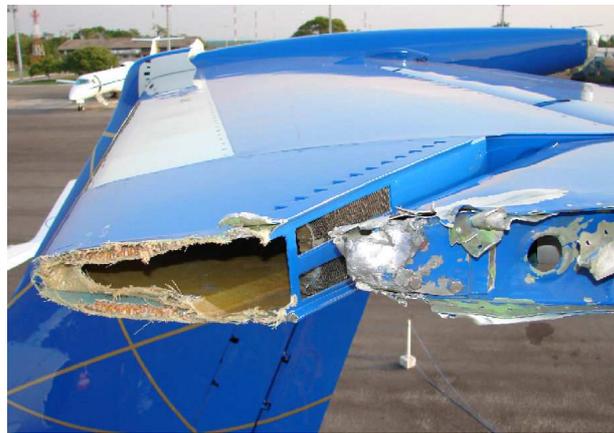
Figure 2

Damaged horizontal stabilizer, N600XL

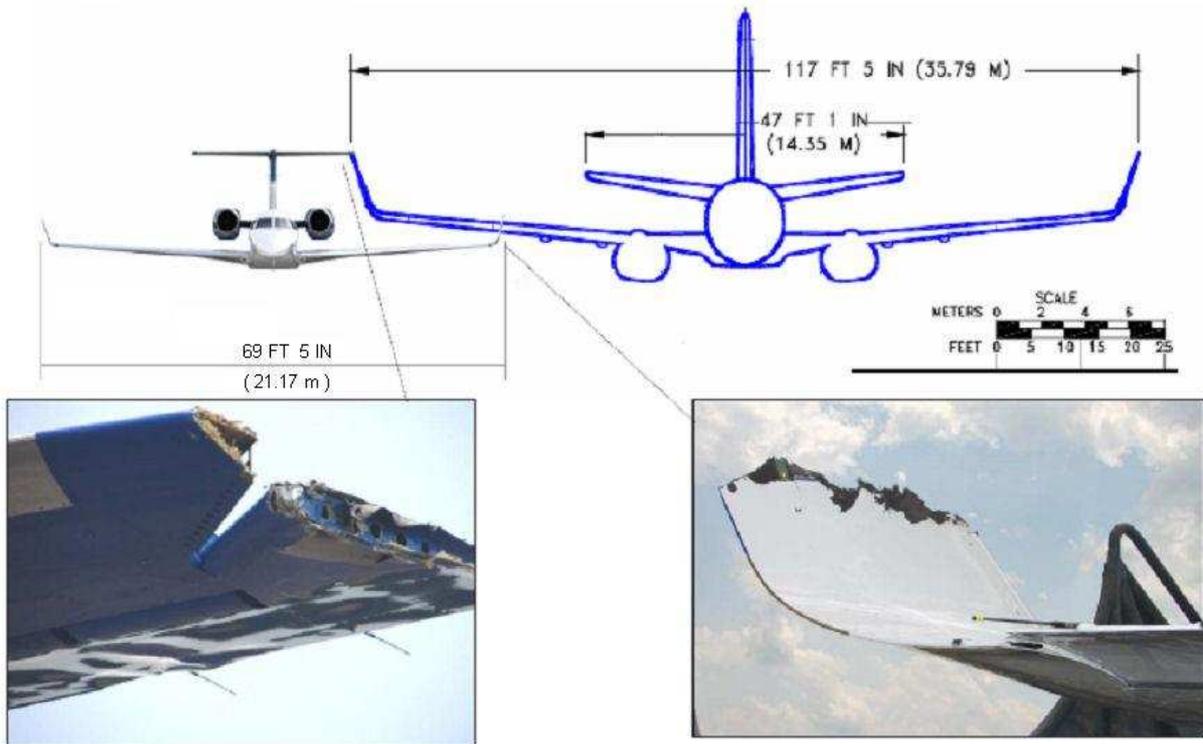
Figure 3

The evaluation of the damages sustained by the N600XL and PR-GTD airplanes allowed the elaboration of a representation of the probable relative position of the two aircraft at the moment of the collision, as shown in figure 3.

Geometry of the collision between the Legacy-600 N600XL and the 737-8EH PR-GTD

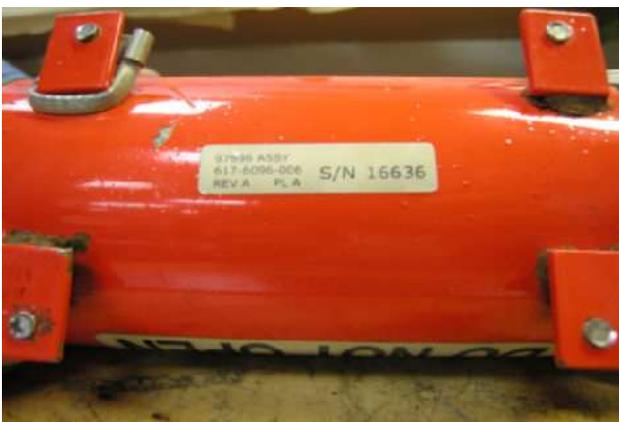
Figure 19: SSCVR protected cylinder, PR-GTD

The direct impact of the SSVR unit against a tree trunk or branch was sufficient for the protected cylinder containing the data (Figure 19) to detach from the rest of the set (Figure 20).

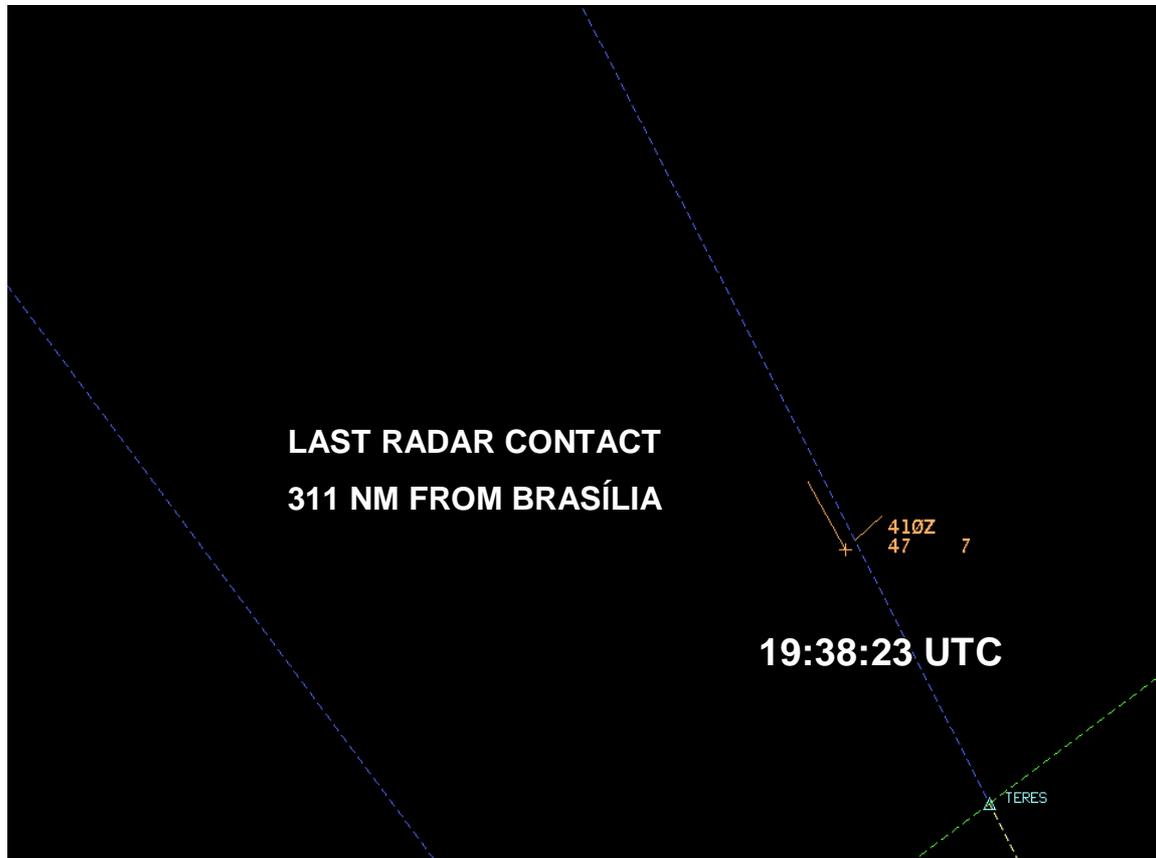
Figure 65

At 1938:23 UTC, the primary radar contact was lost, when the aircraft was at 311 NM. If the transponder had been transmitting, the secondary radar coverage would have been available to the controllers.

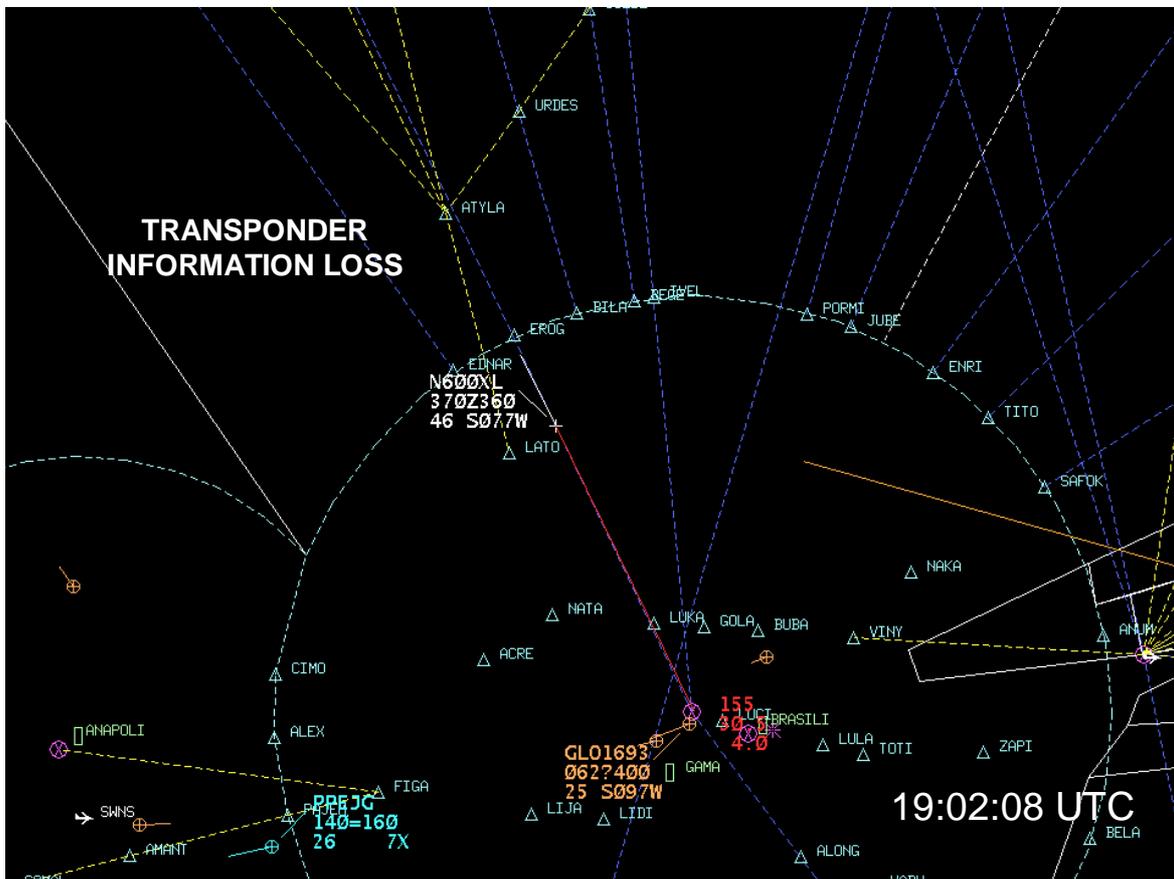
Figure 73 depicts the change in the presentation of the N600XL data block, with the addition of the letter Z after the aircraft measured altitude.

Figure 73 – Presentation of the N600XL data block, after the transponder transmission discontinuance.
