**AERONAUTICAL ACCIDENT INVESTIGATION
AND PREVENTION CENTER**

**FINAL REPORT
A-00X/CENIPA/2008**

OCCURRENCE: AERONAUTICAL ACCIDENT

ACFT REGISTRATION: PR-GTD and N600XL

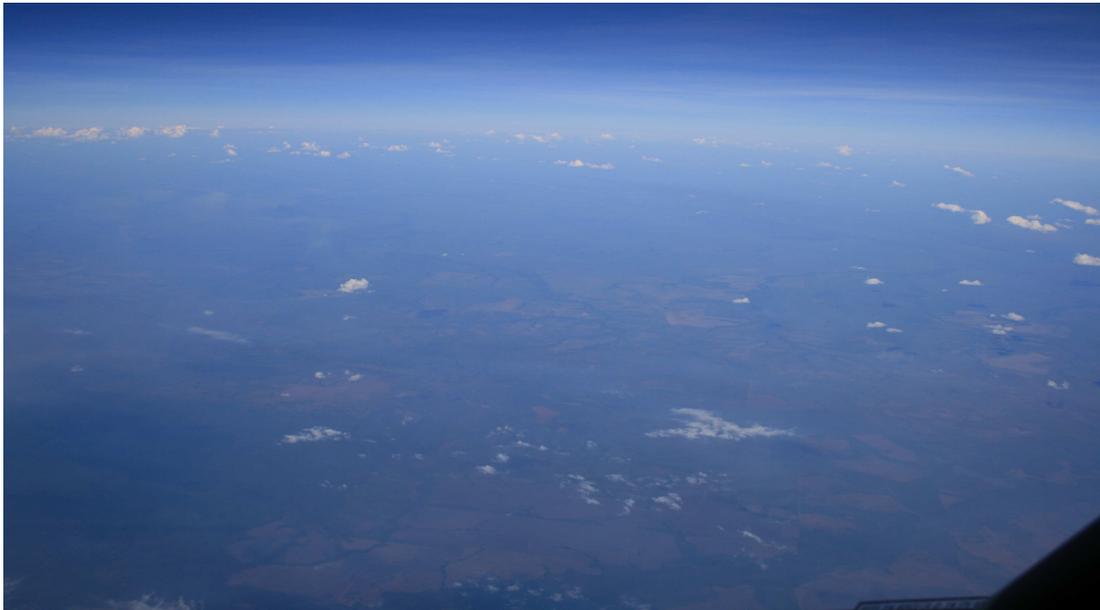
Figure 9 – Photo of the weather conditions along the route of the N600XL

The photo shown below, a courtesy of the N600XL crew, was taken eighteen minutes before the collision (according to the CVR data), about a hundred and thirty five miles away from the point where the midair occurred. As the reports of the pilots and passengers of the Legacy do not tell of any changes in the meteorological conditions during the flight, one may conclude that the weather conditions and visibility were similar to those prevailing at the moment of the collision.

According to reports of local dwellers, residing about 25 nautical miles from the accident area, there was no cloud formation present. Only in some sectors, the horizontal visibility was hindered by mist. It was even possible for one of the witnesses to sight the PR-GTD, from the moment of the collision until a little before its disintegration.

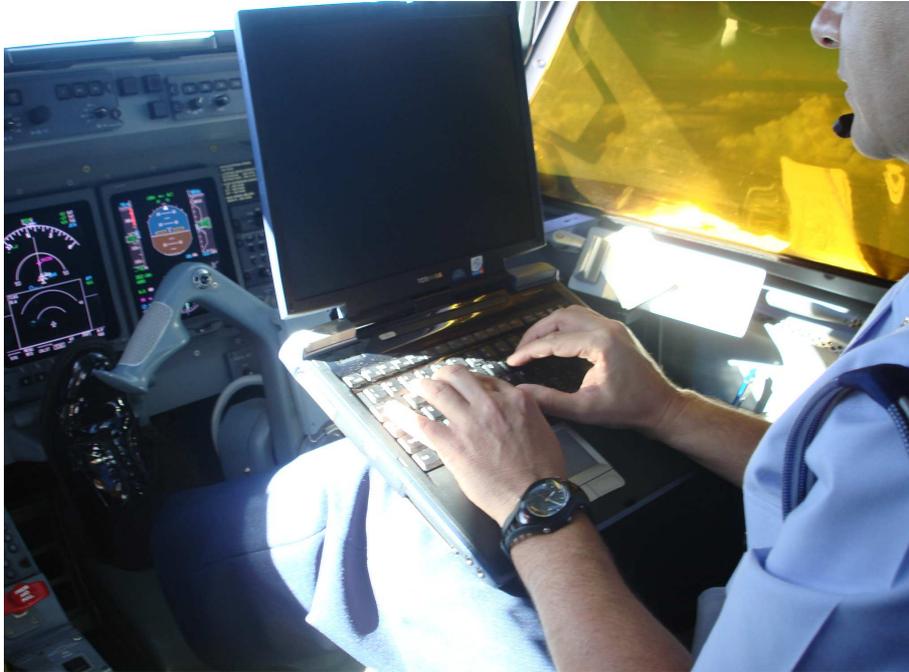
Figure 33

a) Use of the *laptop* by the SIC during cruise flight, leveled at FL370 and FL380. (Figure 33 shows the TCAS Box open, as should be expected):

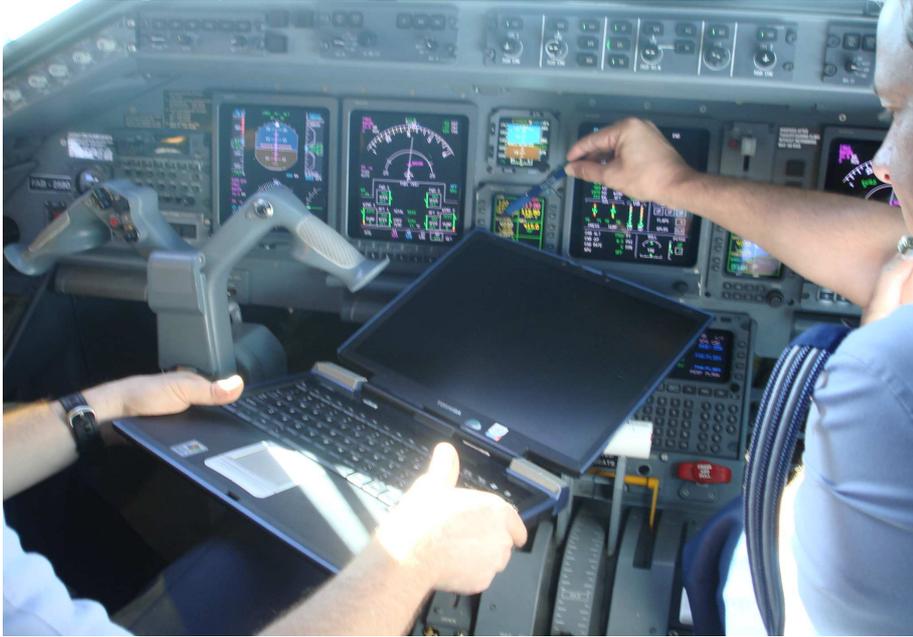
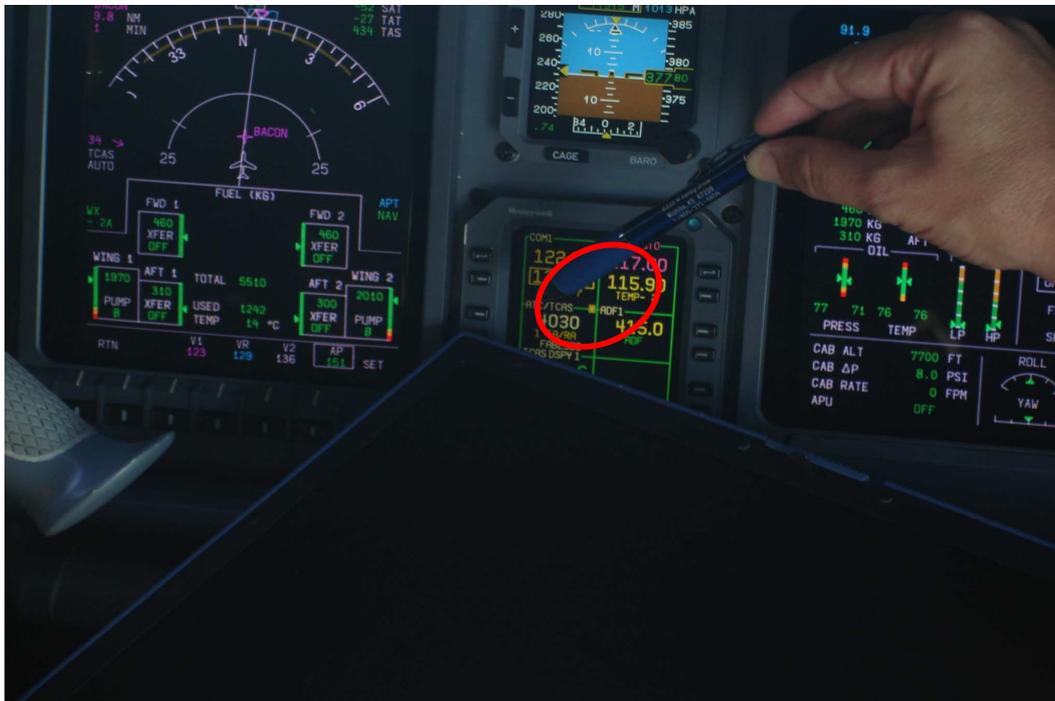
- Likewise, it was observed that the control column is an obstacle for the contact of the *laptop* with the aircraft panel, preventing any type of inadvertent activation of the various systems;
- The *laptop screen* prevents the PIC from sighting the panel ahead and, thus, He cannot see the indications of the Transponder on the RMU and MFD;

- When the *laptop* is handled by the PIC, it is possible for the SIC to maintain normal visual contact with the panel ahead of him, sighting all the visual indications of the Transponder, as well as the indications of the panel ahead of the PIC, even considering the parallax.

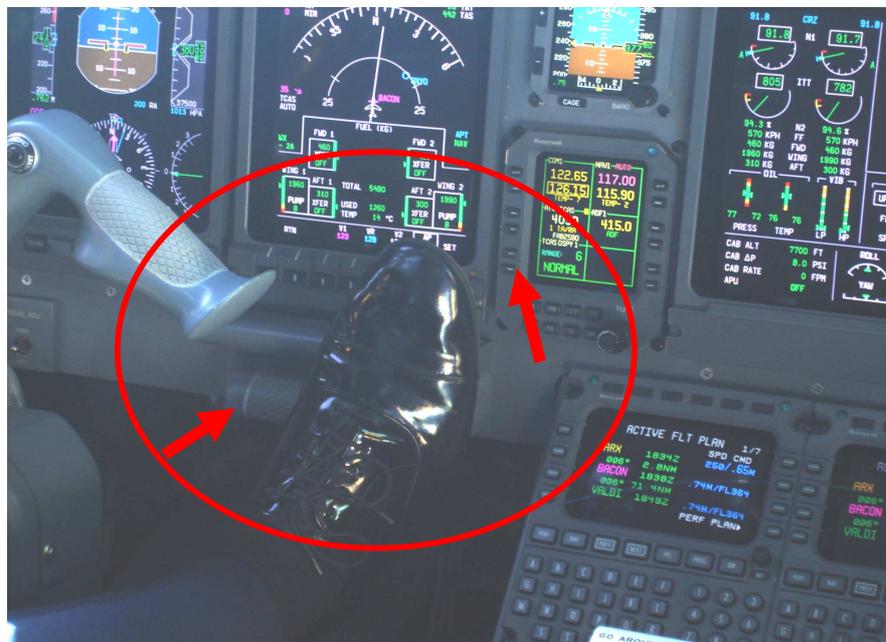
Figure 36

- By handling the *laptop* with the screen open at a pronounced angle (close to horizontal), it is possible to hit the command Button of the Transponder. However, this unintentional action can be easily noticed, as the signals can be monitored visually. On the other hand, one has to consider that it is not logical to operate the *laptop* in such a position;
- All the time, it was possible to observe the indications of the transponder on the various displays, both for the SIC and the PIC. The use of the *laptop* is not capable of interfering in the sighting of the aircraft panel by both pilots at the same time.

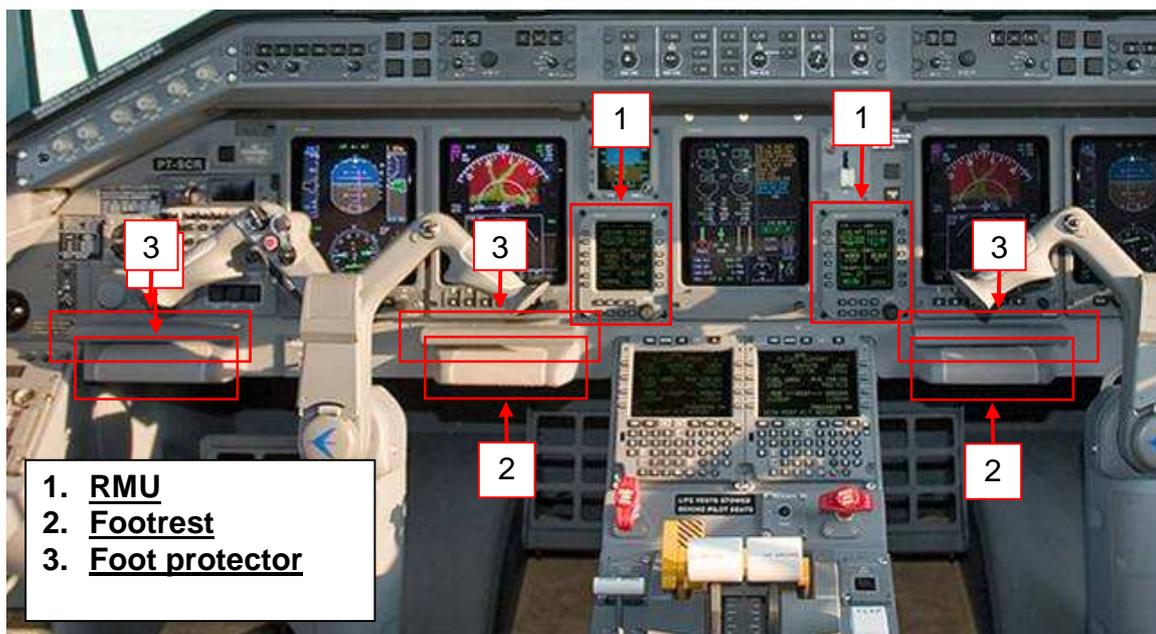
Figure 37

e) Ergonomic Aspects – Considering the positioning of the RMU1 and RMU2 in the instrument panel of the EMB-135BJ as in the picture above:

- With relation to “position”, the location of the RMU in the frontal panel of the aircraft is considered excellent when one verifies the angle of sight from both the PIC and SIC’s perspective.
- With relation to “luminosity”, the perception and understanding of the information of the RMU in the frontal panel of the aircraft were considered of easy interpretation, due to the size of the letters and distribution of colors, even with the intense luminosity present during the flight.

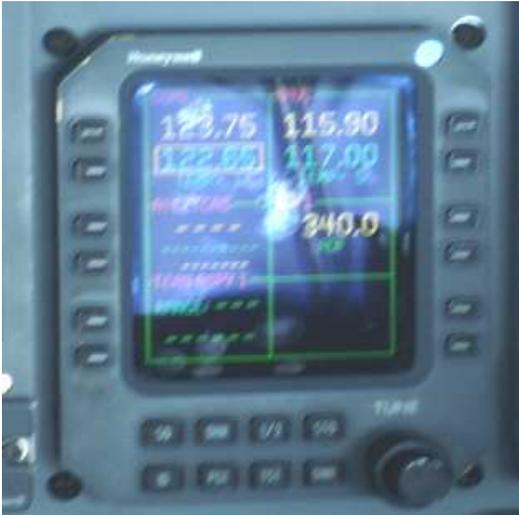
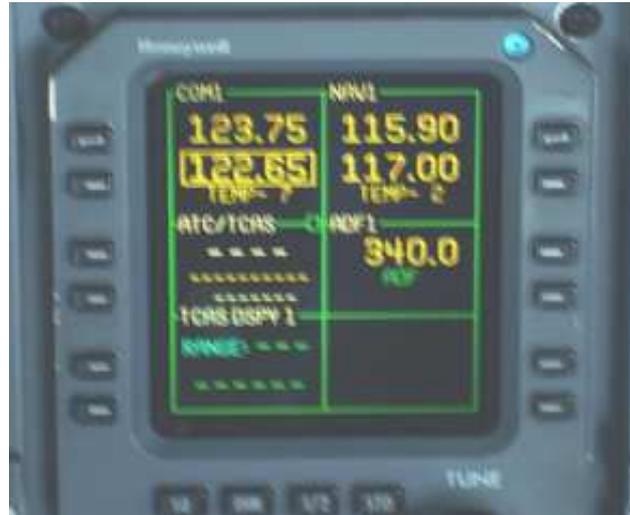
f) Using the RMU1 with simulation of a *Transponder* failure (by pulling the *Transponder Circuit Breaker*):

- The RMU1 was checked in flight in all of its functionalities and the responses in regard of the operation of all the equipment linked to the unit were within the expectations;
- The visual information bear by the RMU1 screen, during the operation were normally intelligible by the crew, without having any difficulty of interpretation;
- With this failure simulation of the *Transponder*, the RMU became “poor” of visual information, which increases the possibility that the indications related to the status of the *Transponder* will be noticed by the crew;
- While this test was being performed, all the visual messages of the *Transponder* status (TCAS FAIL) could be easily identified, both by the PIC and the SIC, while proceeding with the routinely in-flight scanflow, even considering the sunlight intensity at the time.

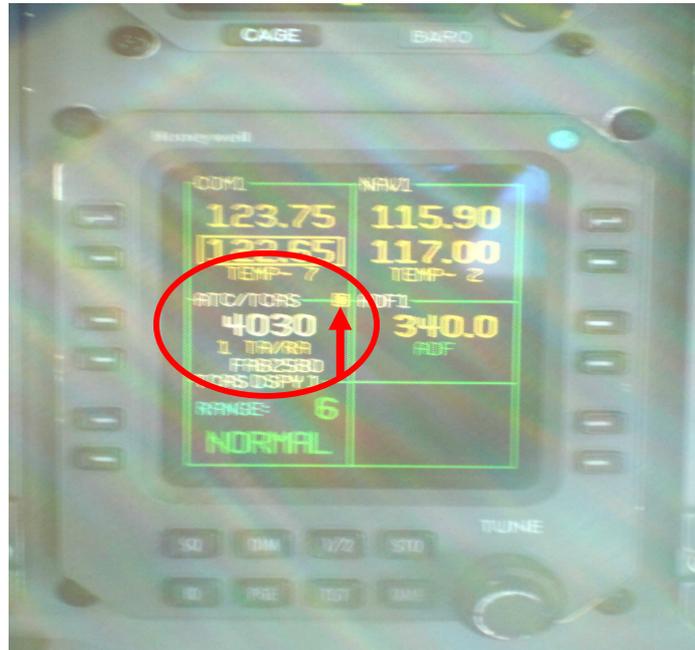
Figura 40

g) Visualization of *Transponder* indication on RMU1 (with a normal sunshine exposure, which corresponded to the same daylight hour as of the September 29, 2006):

- There was no degree of difficulty to note the visual information shown by the RMU screen, related to the *Transponder* modes of operation. As shown by figure 26, the ATC/TCAS mode is in TA/RA;

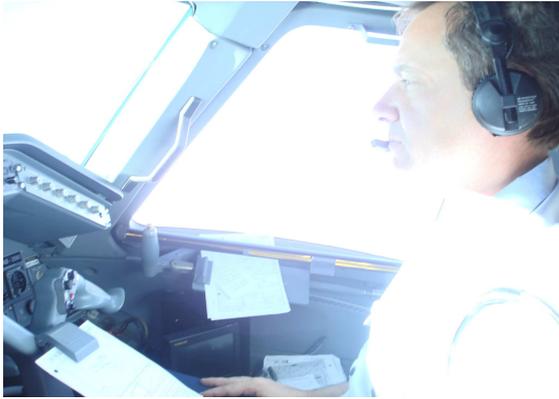
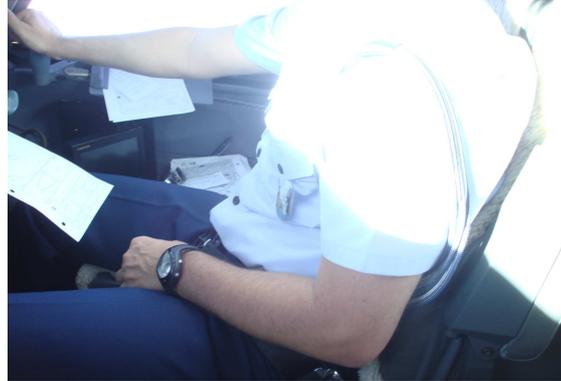
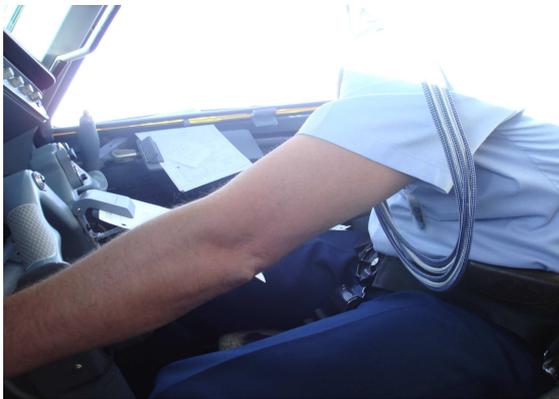
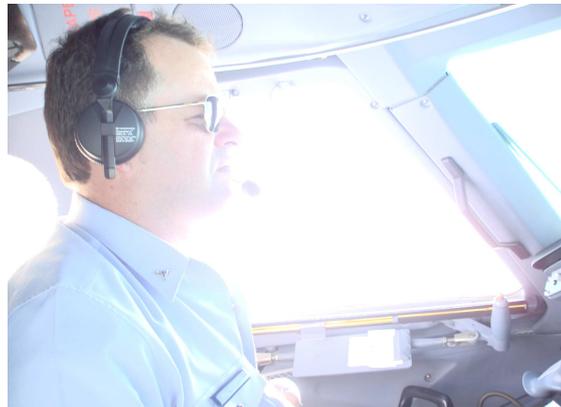
h) Aspects related to the influence of the sun for the visualization of the aircraft panels and their respective instruments (without the use of the sunshades, with lateral views of the SIC and PIC, same magnetic headings and same flight time of the accident flight):

- It is possible to observe that the sunshine touches the SIC on the chest, in a area that is tangent to the chin is above the abdomen (Figures 41 and 42);
- The SIC reported a sensation of discomfort due to the intense heat on his chest;
- As the sunshine touches the SIC below his chin, his eyes end up being protected by the overhead panel, allowing a perfect visualization of the instruments, as they are not directly hit by the sunlight (Figures 38 and 39);
- Since the frontal panel of the PIC is also protected from the sunshine, it is possible for the SIC to visualize it normally (despite the parallax), in the same way he visualizes his own panel;
- For the PIC the conditions were similar, and, even with the sunlight coming from the left, the visualization of the instrument panel was not hindered (Figure 44). There is evidence of the use of the sunshade by the crew.

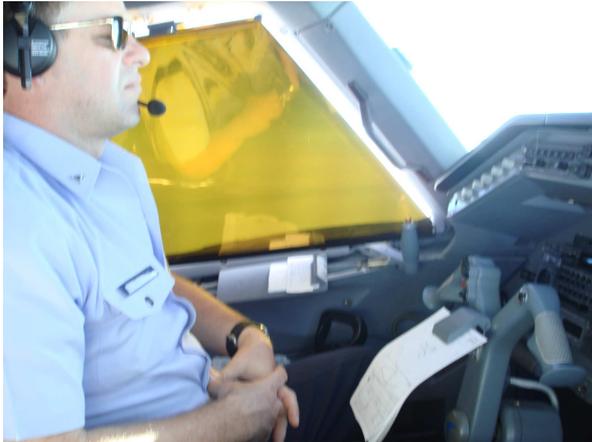
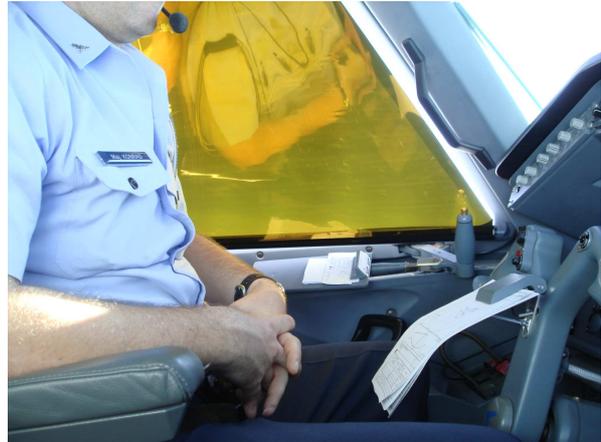
- i) Aspects related to the influence of the sunshine on the visualization of the aircraft panels and their respective instruments (with the use of the sunshade, lateral view of the PIC, same magnetic headings and same time of the accident flight):
- The aircraft possesses an amber color sunshade which proved efficient for preventing the incidence of the sunshine directly on the pilot or on the aircraft panels (Figures 45 and 46);
 - With the sunshade lowered, probably in the same position of the Day of the accident, the comfort of the pilot was rather improved, as the sunshine did not touch his chest directly (Figure 45);
 - The visualization of the instruments improved on account of the lower intensity of the sunlight in the cockpit (Figures 45 and 46).

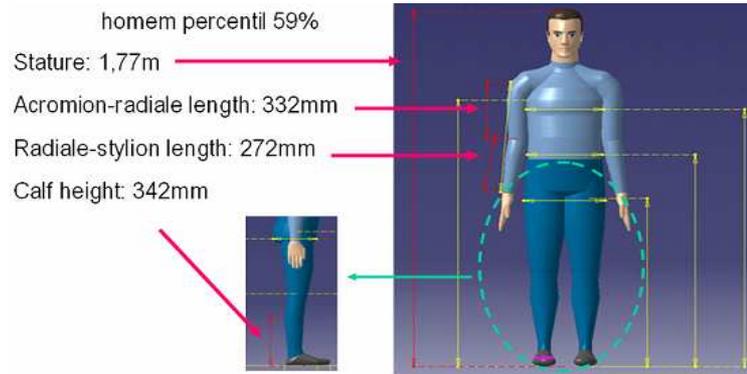
Figure 47

This study was performed based on the actual dimensions of the EMB-135BJ cockpit and utilizing a virtual human model, with the basic estimated measurements from the PIC of the N600XL, which are equivalent to the percentile 59%.

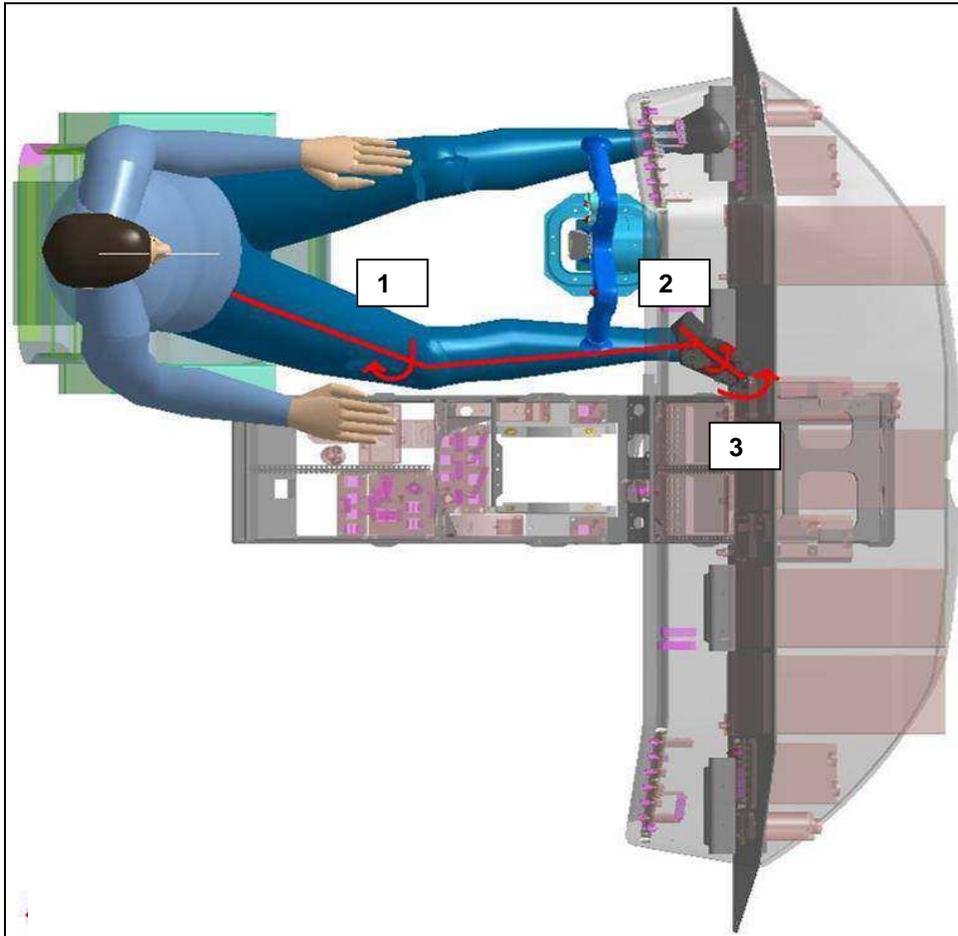
Figure 48

Additionally, the following picture shows the movements the PIC should perform so as to get his foot reaching the RMU1:

- (1) – Thigh lateral rotation
- (2) – Foot Inversion
- (3) – Plantar flexion.

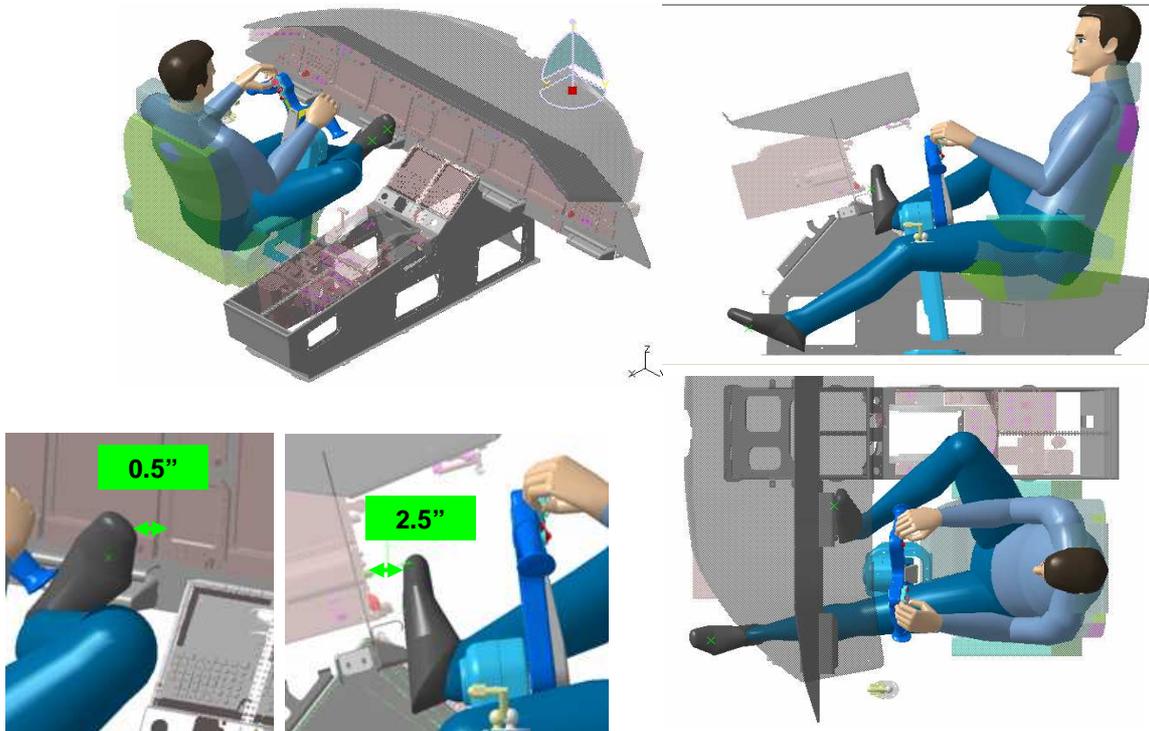
Situation (a): Figure 49 represents the position of the virtual human model, equivalent to the PIC, in the normal flight condition (DEP), using the *footrest* with the seat reclined 10°.

From this Table, it can be observed that all the angles measured in the simulation exceed the comfort limits. The posture of the pilot in this position is unnatural and uncomfortable, this being the same for any attempt to reach the RMU with his foot. These

measurements eliminate the possibility of an inadvertent command from the foot on the RMU.

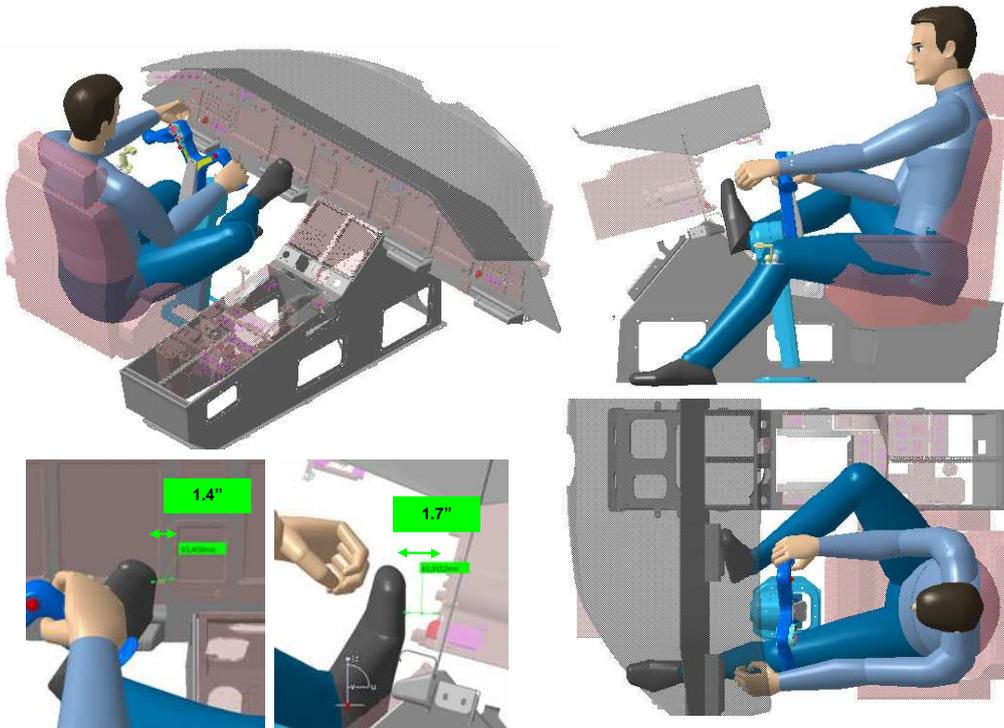
Situation (b): Figure 50 represents the position of the virtual human model, similar to the PIC, trying to utilize the *footrest* with the seat moved 2" back from DEP without reclining the seat and still having access to the primary flight controls (control wheel and pedals):

From this table, the posture of the pilot in this position eliminates the possibility of an inadvertent command from the foot on the RMU, because it is unnatural and uncomfortable.

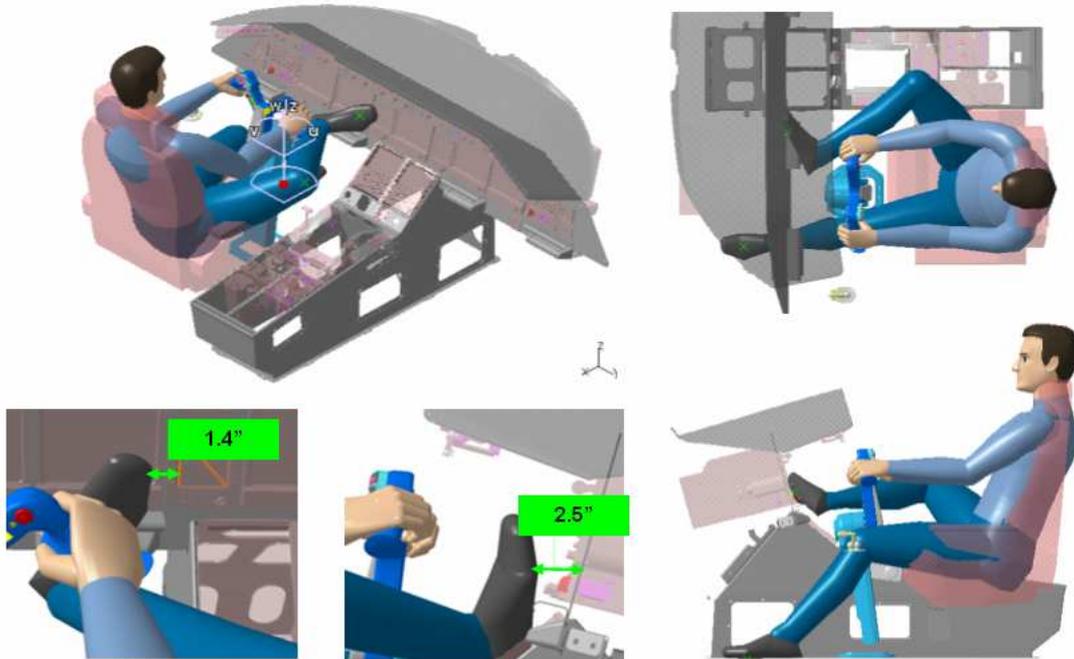
Situation (c): Figure 51 represents the position of the virtual human model, similar to the PIC, trying to utilize the *footrest* with the seat moved 2" back from DEP (i.e., without reclining the seat) and keeping access to the primary flight controls (control wheel and pedals), and now with the seat reclined 10°.

From this table, the posture of the pilot in this position remains unnatural and uncomfortable, which also eliminates the possibility of an inadvertent command from the foot on the RMU.

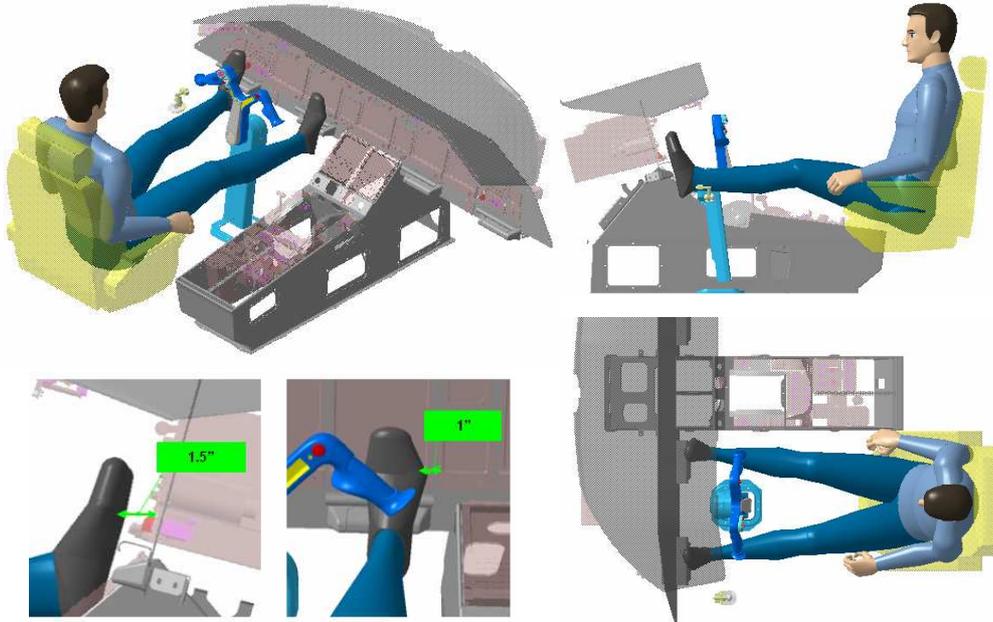
Situation (d): Figure 52 represents the position of the virtual human model, equivalent to the PIC, trying to utilize the footrest with the seat all the way to the back and without reclining the seat:

Simulation Foot on footrest	Simulation attempt Foot on RMU	Comfort Range
Thigh Flexion	74,8°	80.3°	60° to 85°
Thigh Abduction	6,5°	10.4°	0° to 20°
Thigh Rotation	0°	-23.8°	-15° to 15°
Leg Flexion	17°	19.8°	45° to 85°
Leg Rotation	0°	-17.6°	-5° to 5°
Plantar Flexion	-13,9°	- 45°	0° to 25°
Inversion	0°	3.3°	0° to 13°

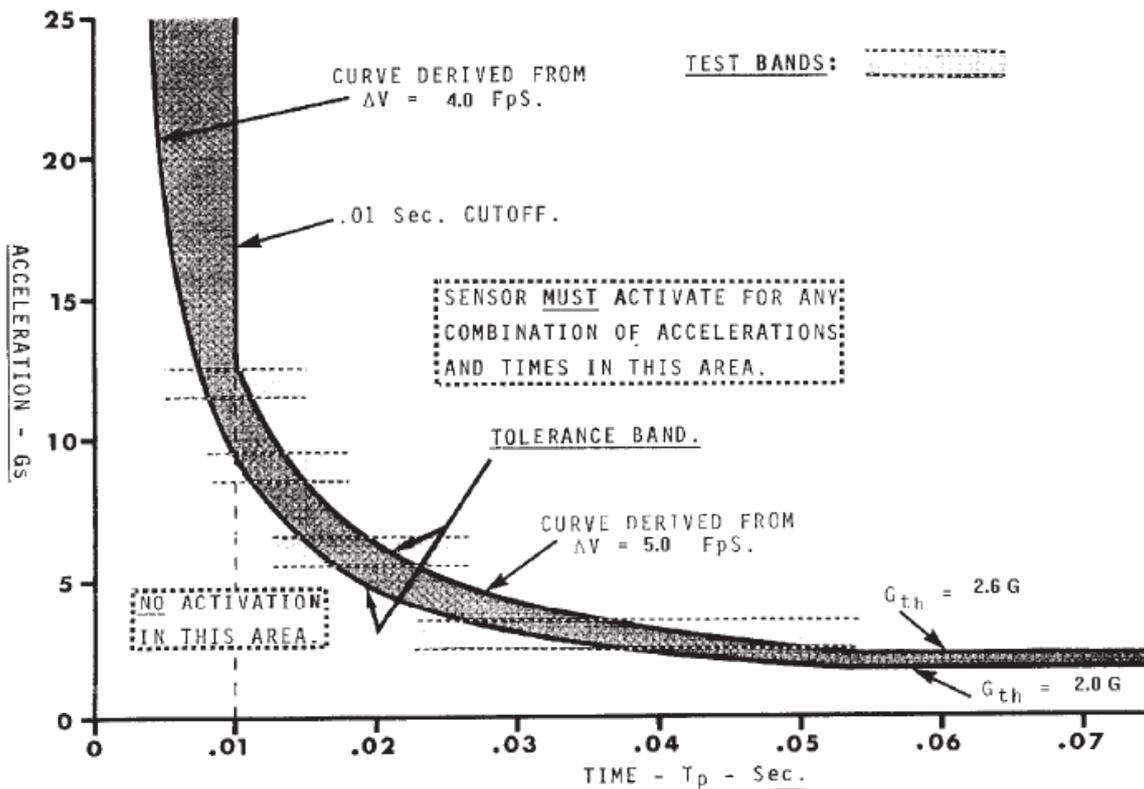
Figure 53

The crash force activation sensor or G-Switch is designed to activate according to the plot time versus longitudinal G force as shown by the Figure 1. For short impact the G force to activate the ELT is much higher than a relatively long impact.

After the N600XL and PR-GTD collision, no signal from the PR-GTD ELT was received by COSPAS/SARSAT system to help the search and rescue effort. While the PR-GTD was already in a spiral dive and before it suffered the in-flight breakup, the recorded FDR information revealed that the longitudinal acceleration did not exceed 0.5 G. This value was not sufficient to activate the ELT, according to figure 1.

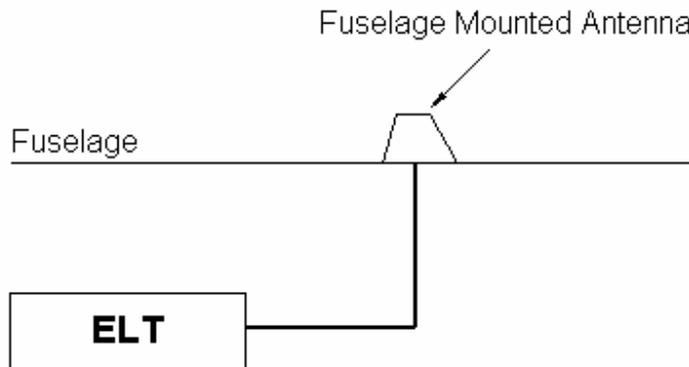
Figure 54

The ELT installation includes a fuselage mounted antenna (Figure 2). If the cable between ELT unit and respective antenna is damaged, the transmission of the signal will not occur.

After the in-flight breakup of 737, probably the connection between the ELT unit and respective antenna was damaged or the tail crashed vertically, preventing any possible signal transmission.

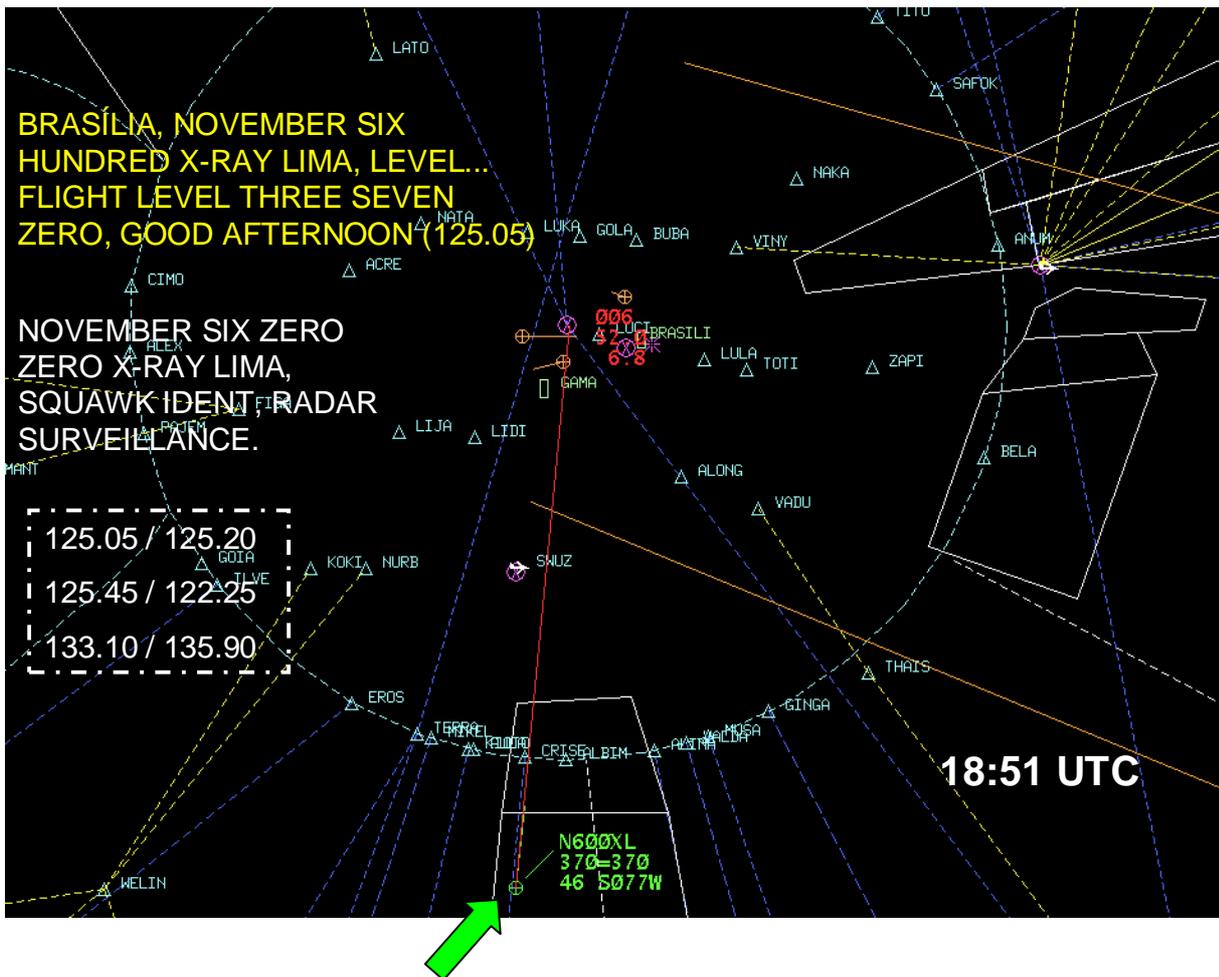
Figure 55 above depicts a view of the data block at the moment of the last two-way radio contact with Brasilia Center, sector 5, on the frequency 125.05 MHz.

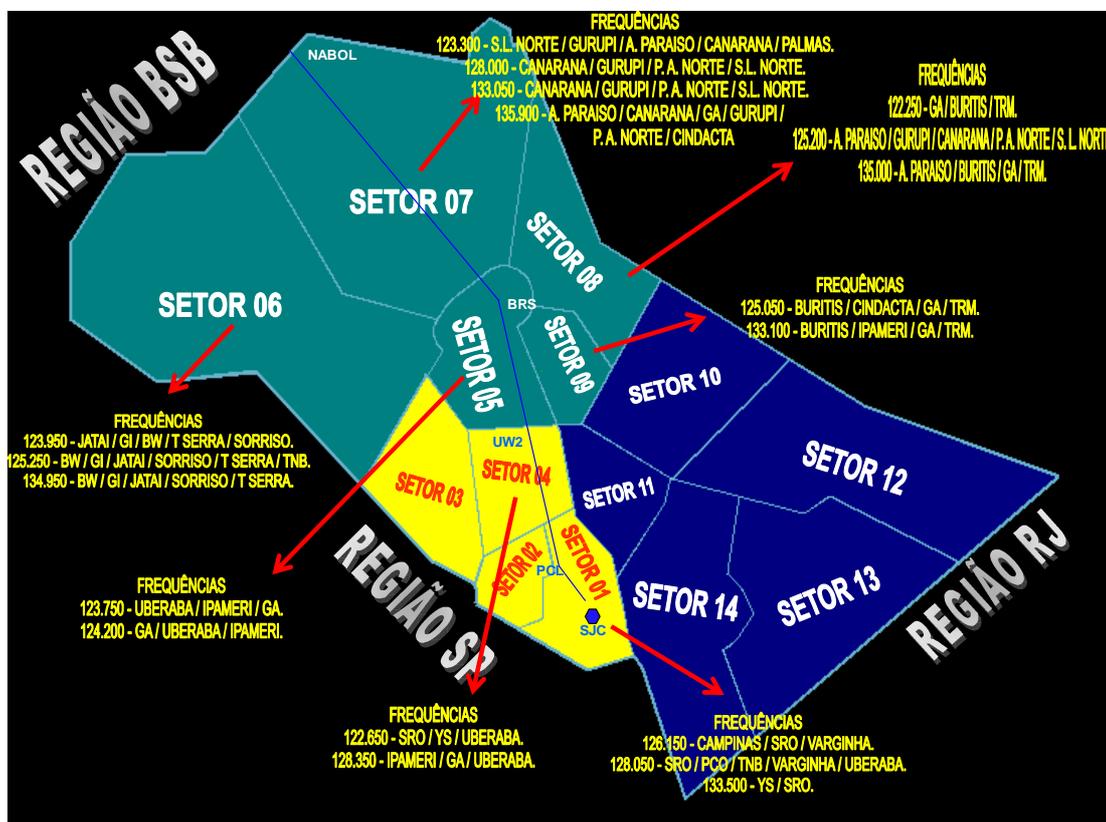
Figure 57

When the controller verified the aircraft entering sector 7, to the north of Brasilia, he had to have instructed the aircraft to change frequency to 135.9 MHz, in accordance with the sector frequency table (Figure 57), besides analyzing and deciding about the adequate instruction regarding the change to FL360 authorized by the active flight plan.

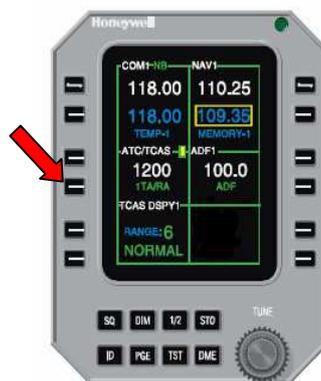
Figure 58

For the Standby mode to be selected, it is necessary to press the fourth top to bottom left button, in one of the RMUs (it has to be pressed twice in a 20-second interval).

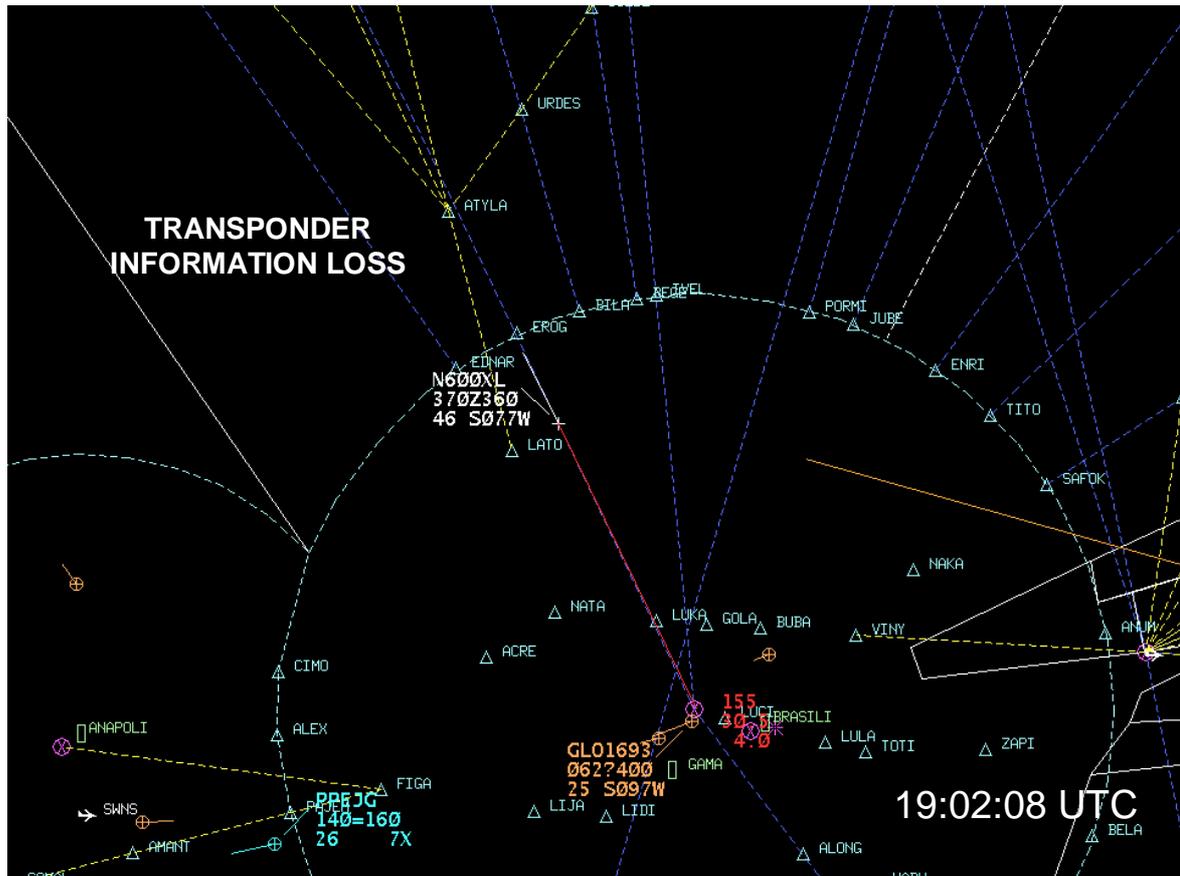
Figure 59

As seen in figure 59, the white data block pertaining to N600XL displays a letter Z between the two levels earlier identified as NIV and CFL, according to the ATECH Controller's Manual already mentioned, meaning **aircraft with a valid 3D altitude**. This meant that, from that moment on, the altitude information relative to that aircraft **was being obtained by 3D primary radar equipment and not from the transponder mode C** any longer.

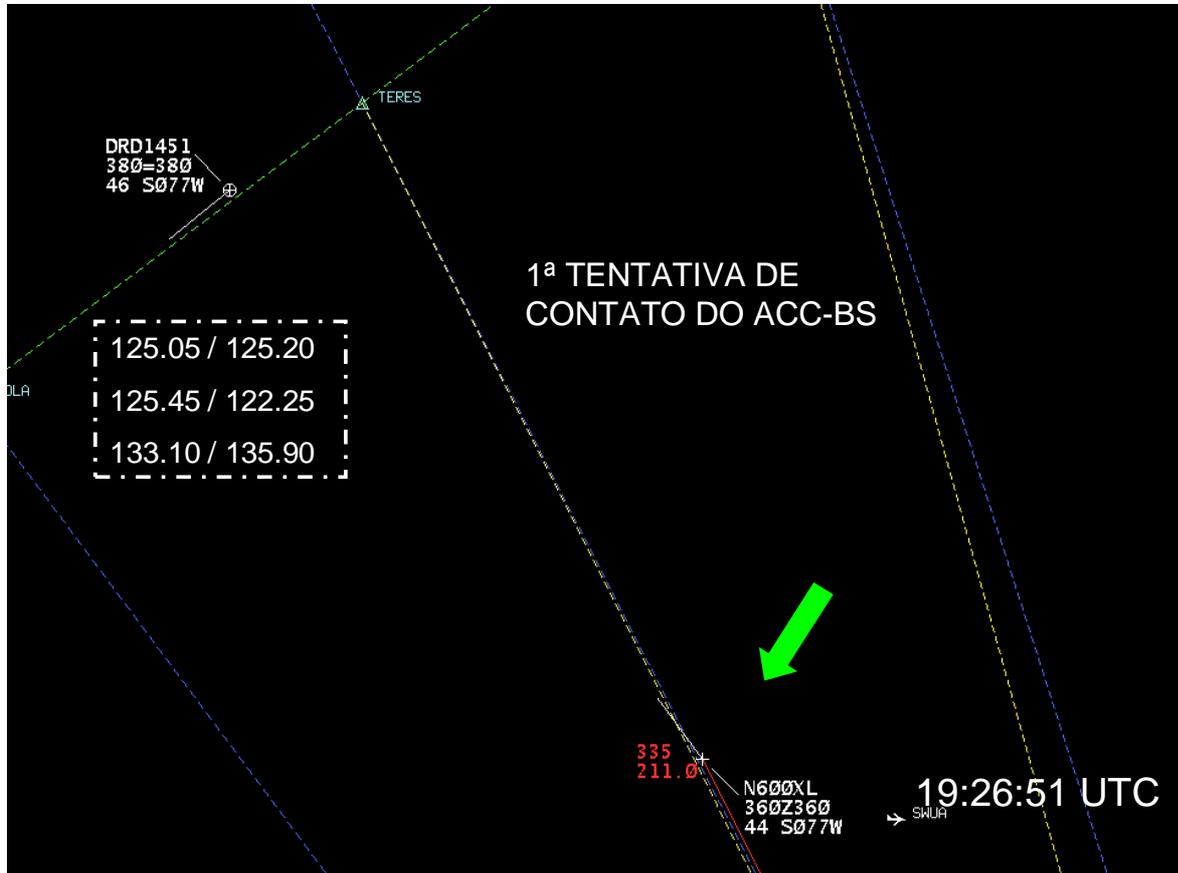
Figure 60

Despite being transmitting on 125.05 MHz, the first call was only made when the aircraft was already at **211 NM away from BRS VOR.**

The aircraft icon still showed a correlation between the primary radar and the 3D radar returns.

The effective range of the frequency 125.05 MHz at FL 300 is 300 NM. Although the aircraft was within the frequency theoretical maximum range, the positioning of the aerials is for sector 09.

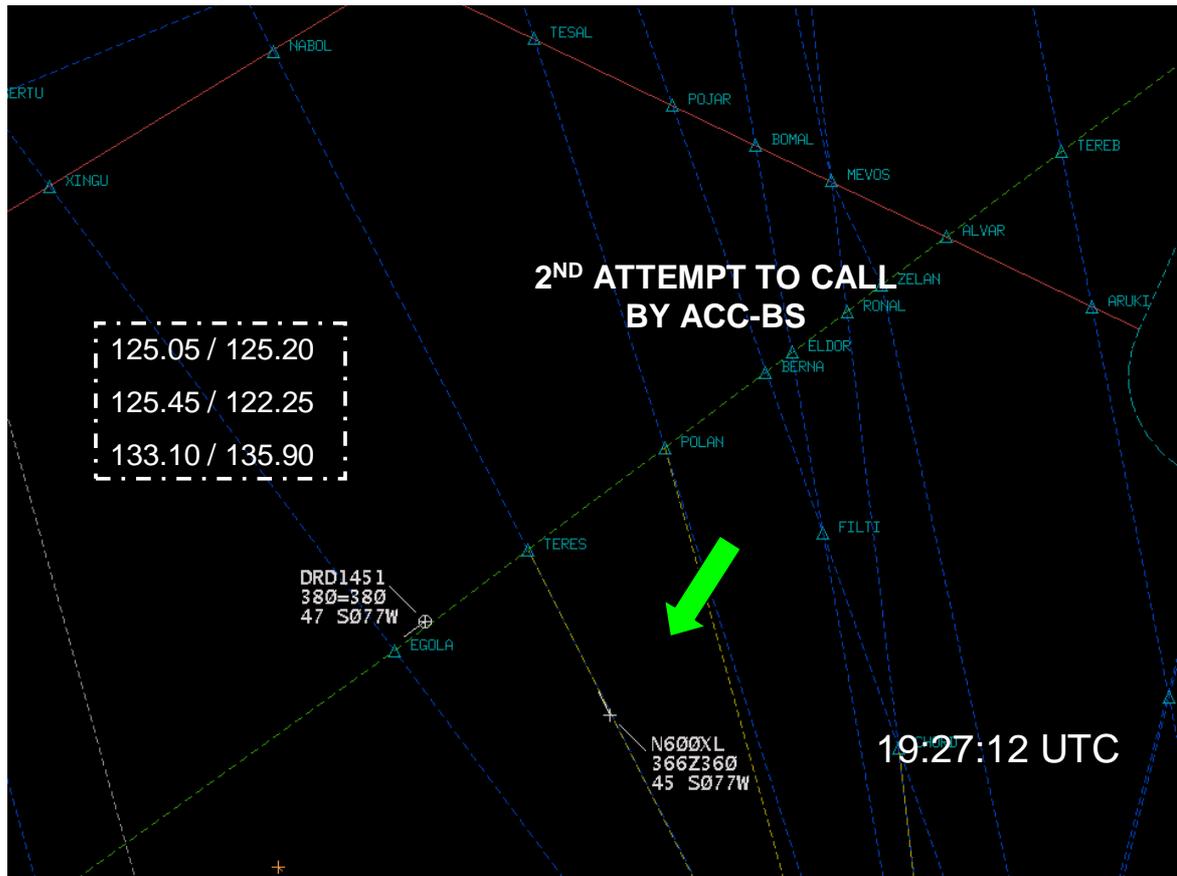
Figure 61

At the **second attempt, at 19:27:12 UTC**, for the **first time** a frequency change to **135.9 MHz** was commanded. Such a command should have been given, at least, 30 minutes earlier.

The aircraft was already at **218.5 NM from BRS VOR**, still with primary radar contact and correlation.

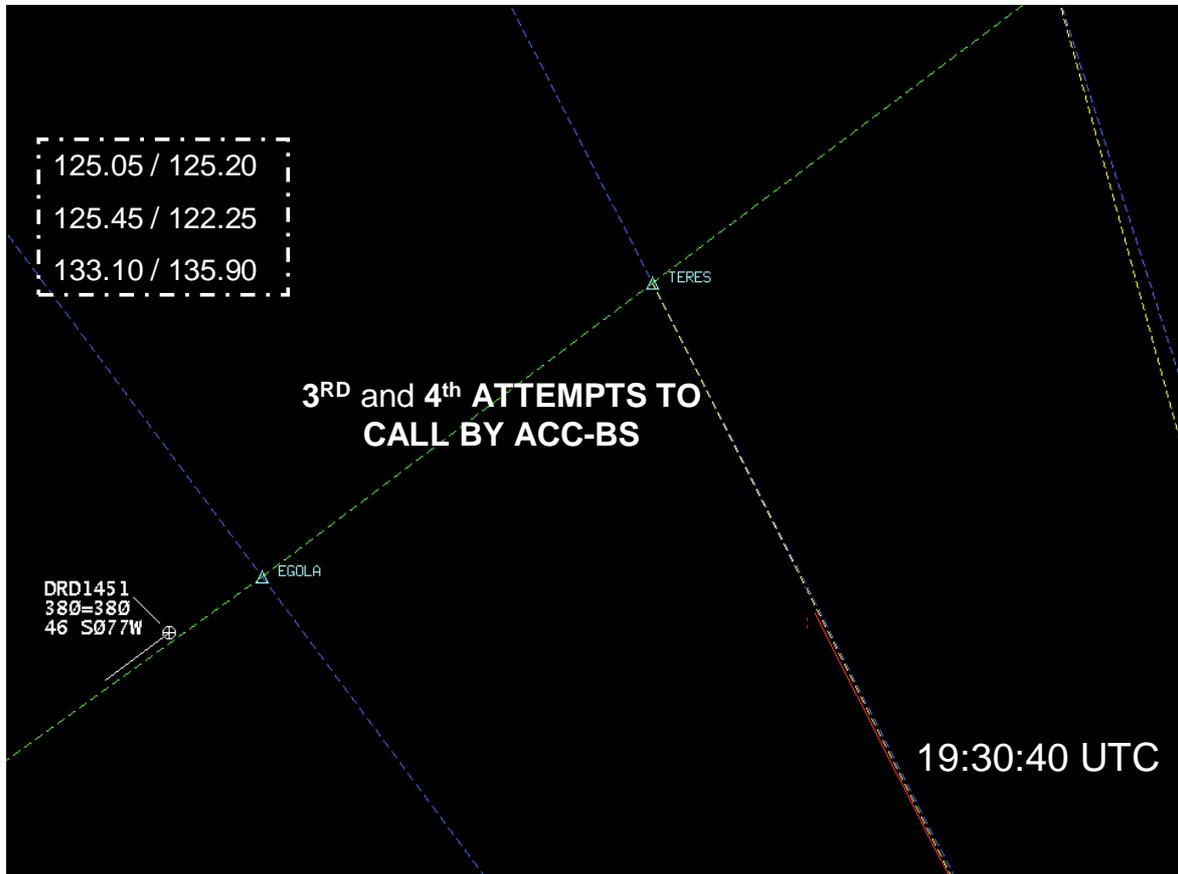
Figure 62

The ACC lost primary radar contact with the aircraft for two minutes. A **third attempt of radio contact** was made, at **19:30:40 UTC**, when the aircraft was already at **248 NM** from BRS VOR.

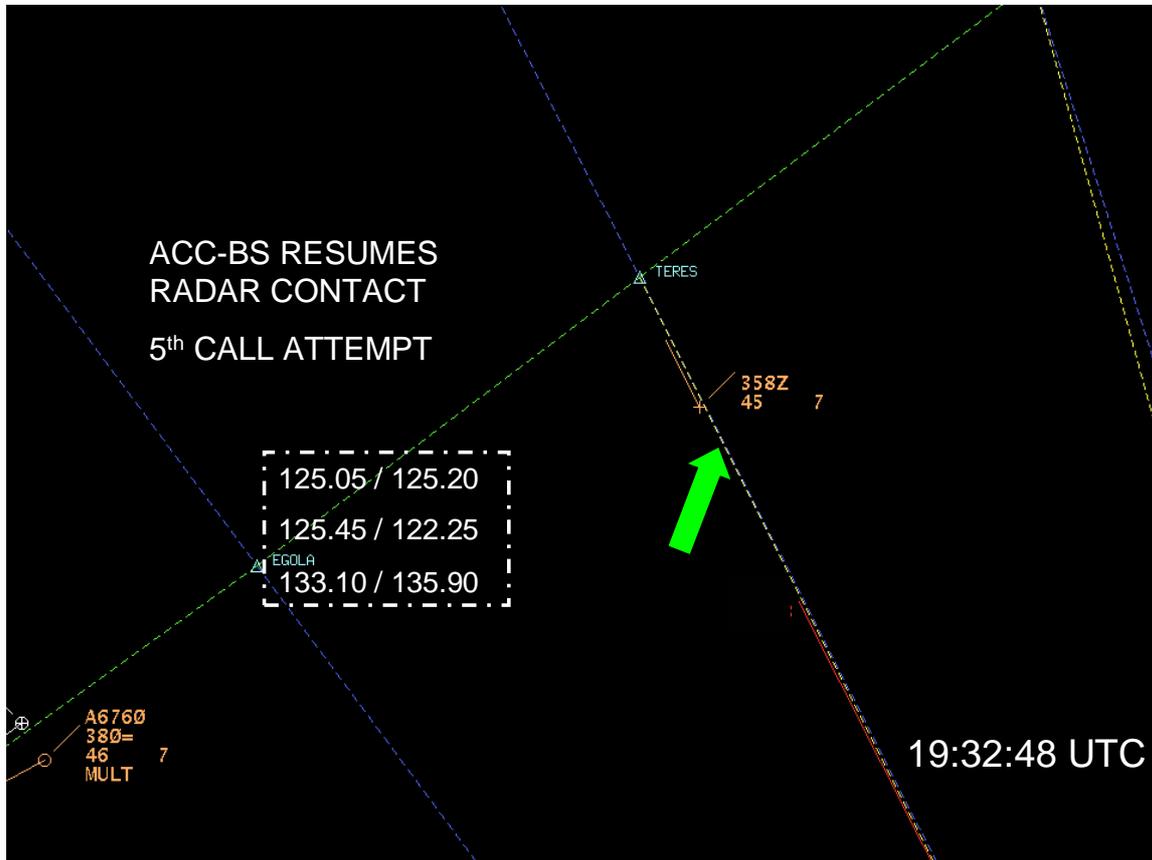
Figure 63

At **19:32:48 UTC**, the aircraft reappeared as a primary radar contact, at **265 NM**, but now without its correlation symbol. Instead of the earlier data block, it had only speed and 3D radar altitude information. This type of altitude information can not be used for vertical spacing under RVSM. The controller then made the **fifth** unsuccessful **attempt** to contact.
