**AERONAUTICAL ACCIDENT INVESTIGATION
AND PREVENTION CENTER**

**FINAL REPORT
A-00X/CENIPA/2008**

OCCURRENCE: AERONAUTICAL ACCIDENT

ACFT REGISTRATION: PR-GTD and N600XL

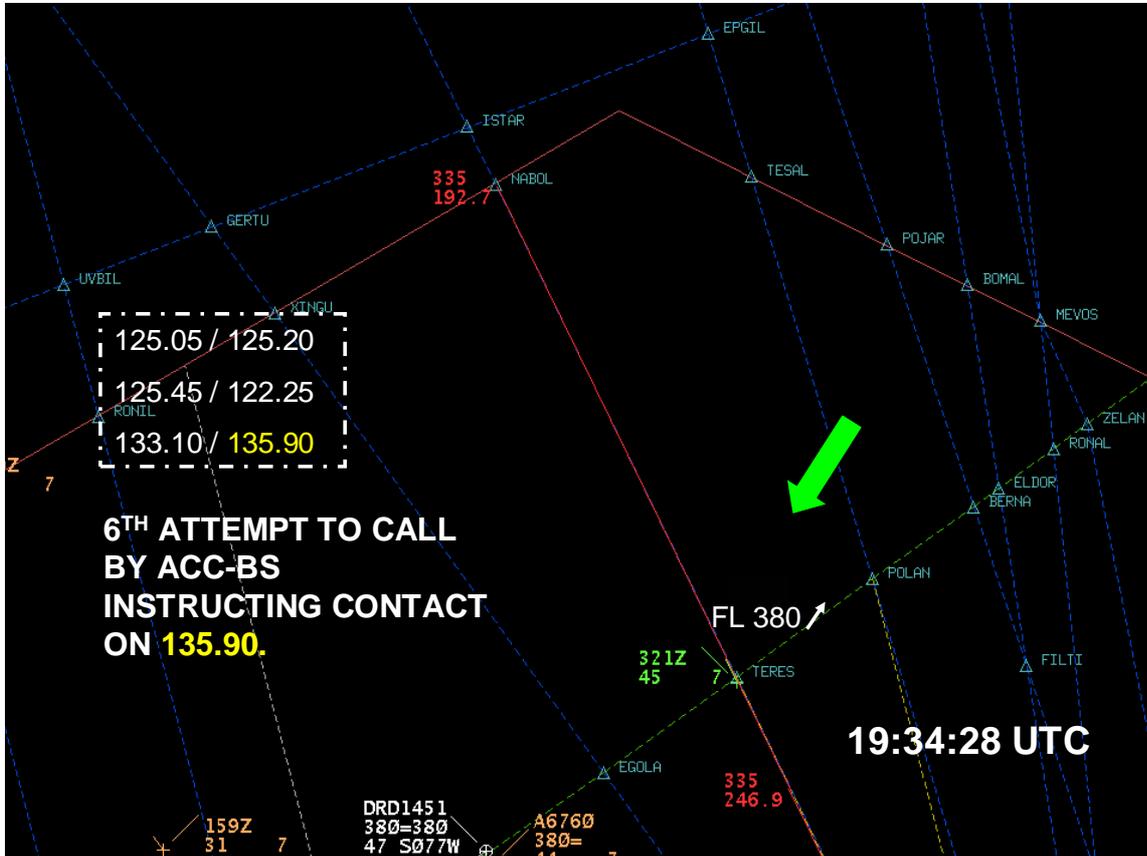
Figure 64

At **19:34:08 UTC**, the controller made the **sixth attempt**, and for the **second time** he added an instruction of frequency change to **135.9 MHz**, when the aircraft was already at **280 NM**.

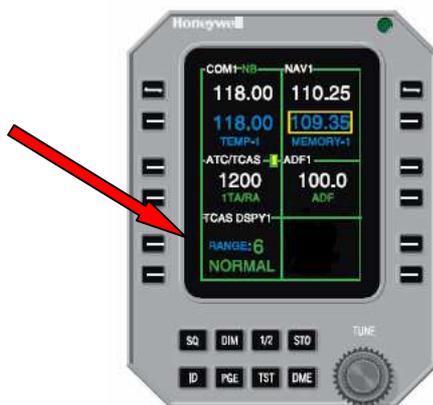
Figure 66

in the RMU, mainly due to the fact that the field that indicates the operation mode of the transponder in the RMU is located just below the field "COM".

WINDOW INDICATING THE MODE OF OPERATION

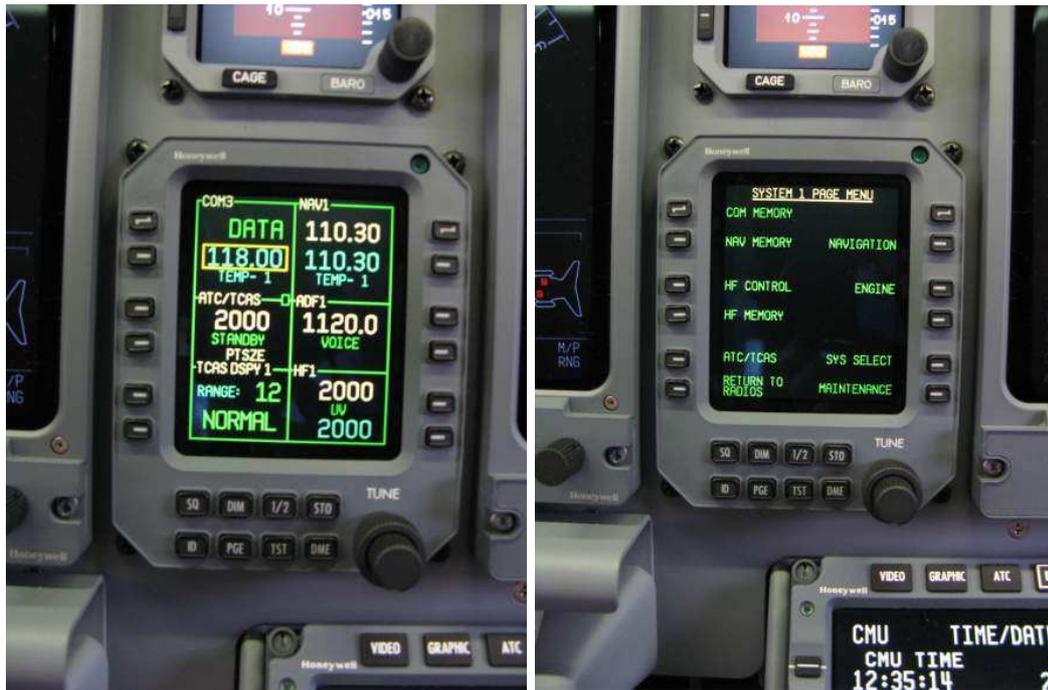
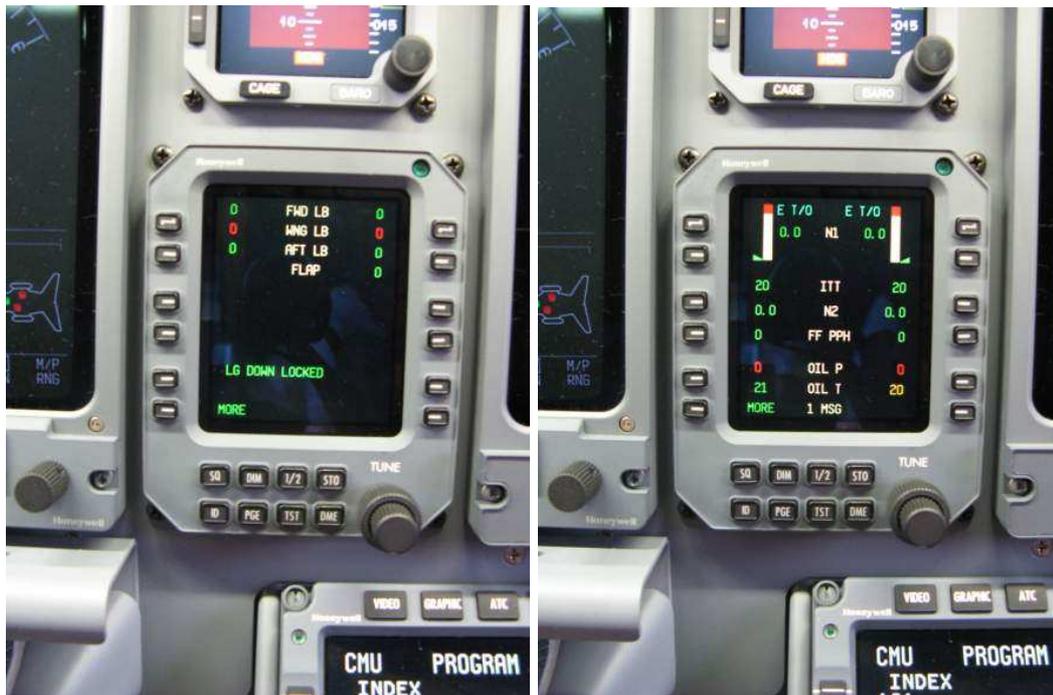
Fig. 67 and 68 (Adjustment of communication and navigation frequencies)

The RMU is used primarily for adjusting the navigation and communication frequencies. It also functions as a backup for the EICAS; therefore, pages of the RMU can be accessed to check the fuel status, engine parameters, flap position, TCAS, etc., as shown in the Figures below.

Fig. 69 and 70 (as a back-up, pages with information of the fuel system and engine parameters.

Therefore, it is possible that, while handling the pages of the RMU, the captain unintentionally set the Transponder to STANDBY, by pressing the RMU button twice in less than 20 seconds, without being aware of his action.

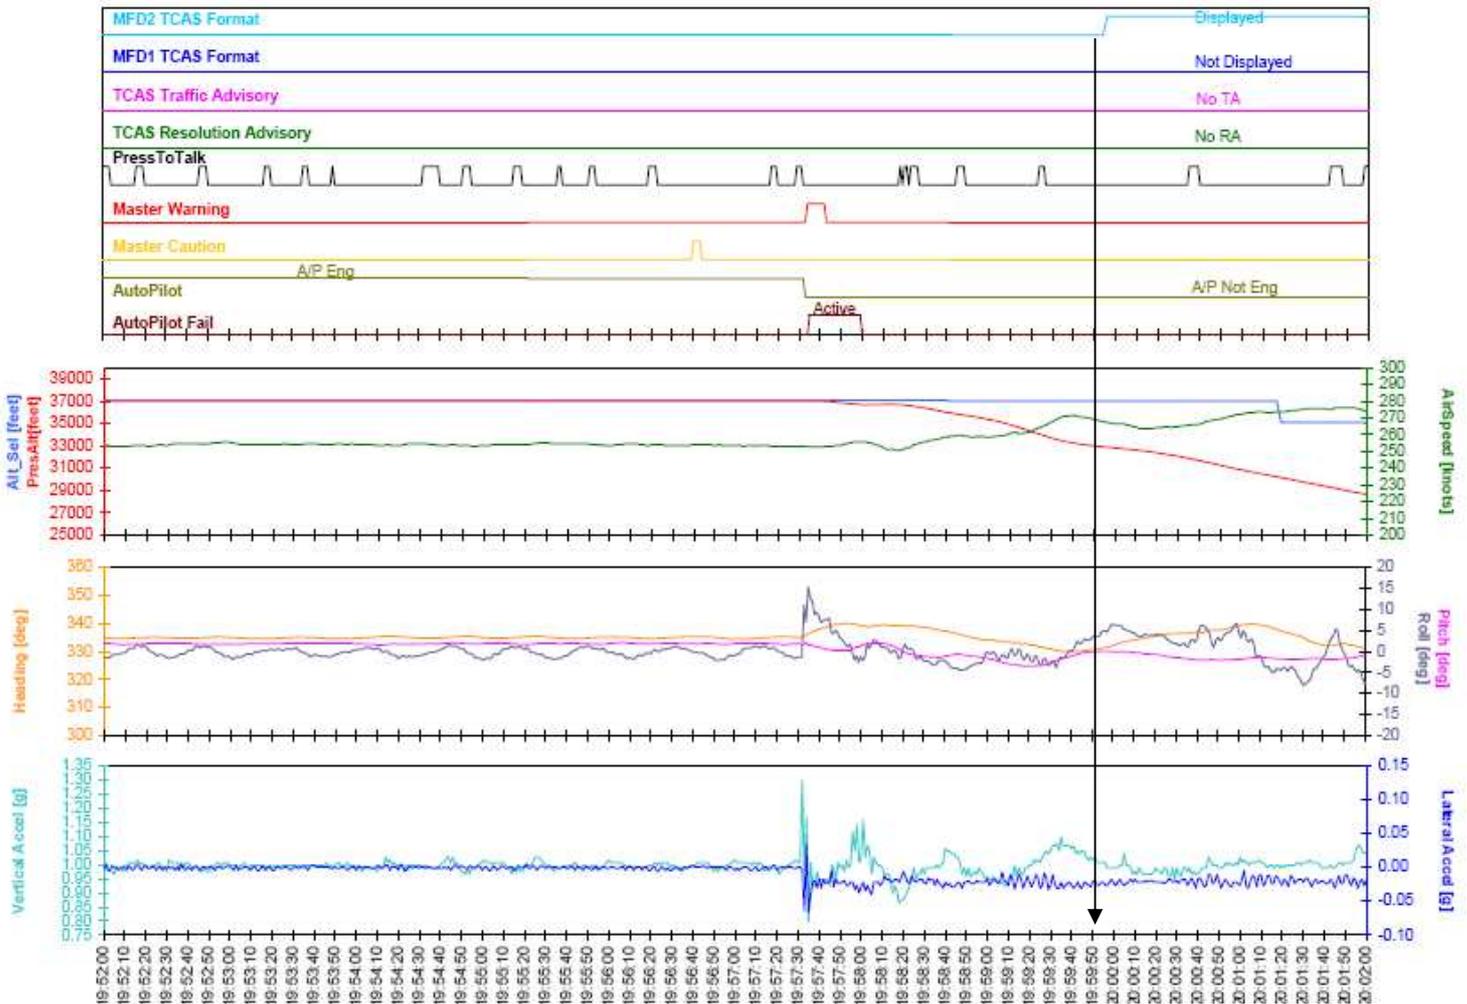
Fig. 71

The Figure 71 (above) shows the data from the DFDR of N600XL, with the opening of the TCAS screen on the MFD2 display (co-pilot side), precisely at 19:59:50 UTC.

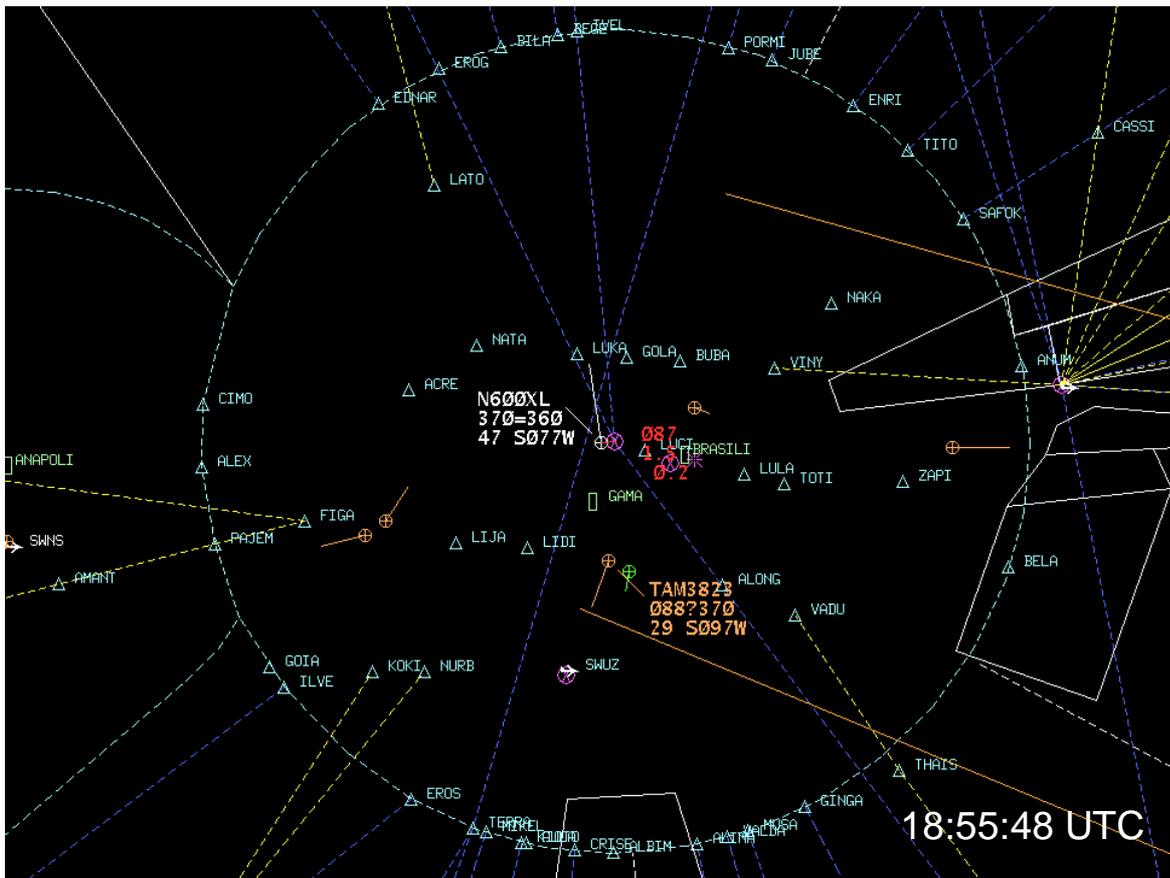
Figure 72 – RADAR presentation of the STVD at CINDACTA I

After the vertical of BRS VOR, the data block pertaining to N600XL started to show, as specified, the information 370=360, warning the controller that the aircraft was at flight level 370, while the level authorized for that segment was FL 360 (See Figure 70).
